Dorra ABID, Ahmed KTARI, Dhouha MELLOULI, Nedja GAFSI, Nader HADDAR - Failure analysis of shot-sleeves used in brass high pressure die-casting process - Engineering Failure Analysis - Vol. 104, p.177-188 - 2019

# Failure analysis of shot-sleeves used in brass high pressure die-casting process

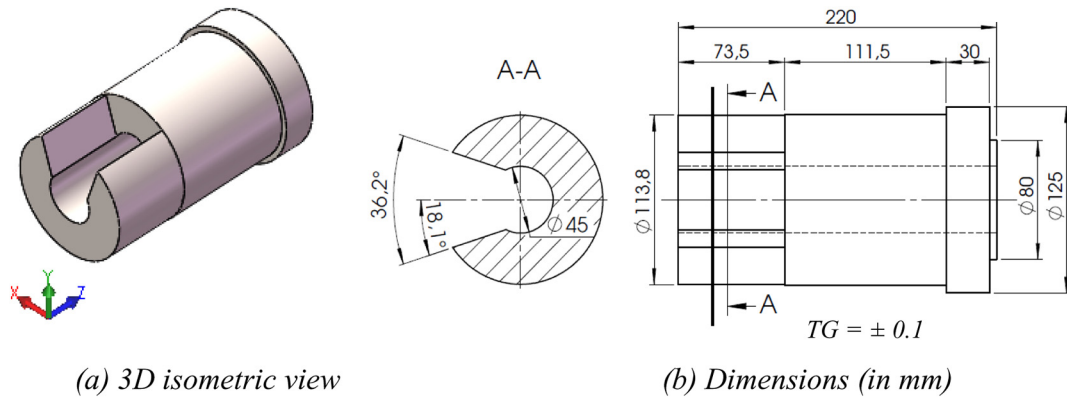
Fig. 1. Geometry and dimensions of the studied shot-sleeves.

In the present study, samples of shot-sleeve failed in service, were investigated to understand the mechanisms, which can lead to their damage. The shot-sleeve (Fig. 1), used in brass high pressure die-casting process, undergoes a severe thermo-mechanical loadings during cast cycles. Each cycle include principally four phases as following:

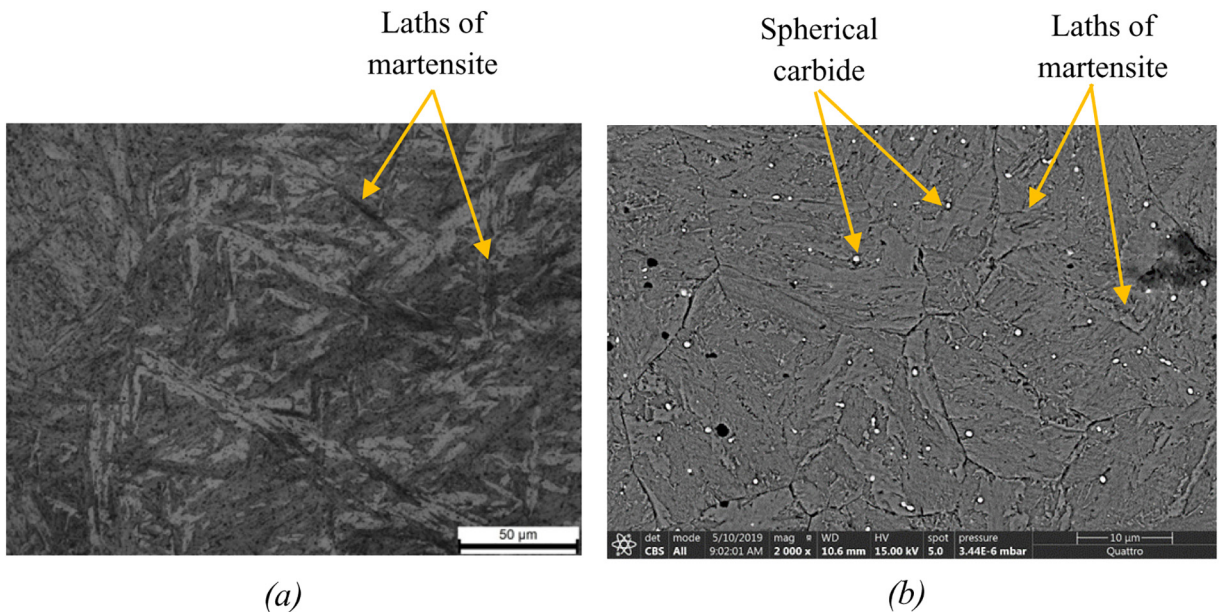
Fig. 2. Microstructure of the shot-sleeve: (a) Light Optical Microscopy (LOM), (b) The SEM microanalysis.

Our studied material is H10, a metallographic observations were realized by means of an optical microscope (Leica®) on the same taken sample polished until mirror state then attacked by Nital (5% of nitric acid diluted in methanol). These observations show the presence of a martensitic structure ([Fig. 2](#)).

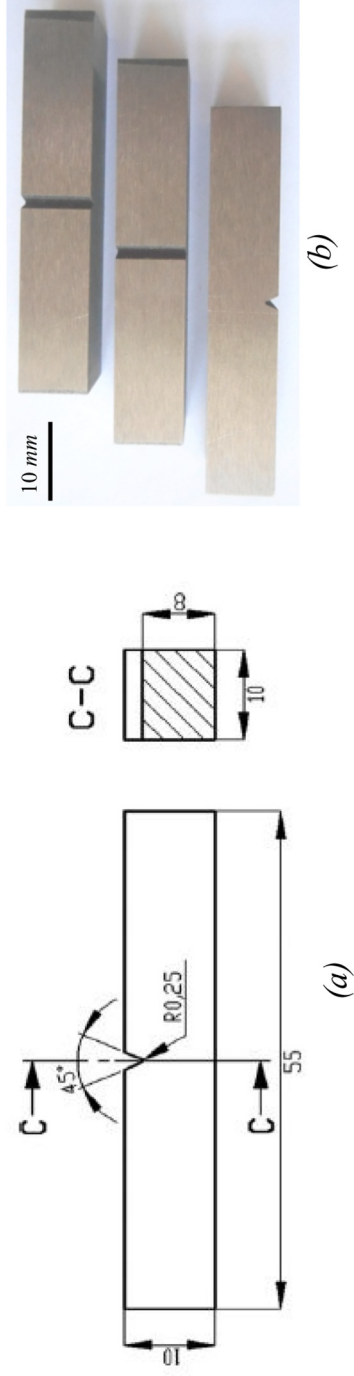
Fig. 4. Charpy V-notch specimens: (a) Geometry and dimensions (in mm), (b) machined Charpy V-notch specimens.

Standard Charpy V-notched specimens were machined from the failed shot-sleeve by a wire EDM machine (Fig. 4). Then, three tests were conducted at room temperatures to determine the material toughness. The average of the measured CVN energy ( $CVN = 3.4 \pm 0.1$  J) and the feature of the fractured surface prove the brittle nature of the specimen material (Fig. 5).

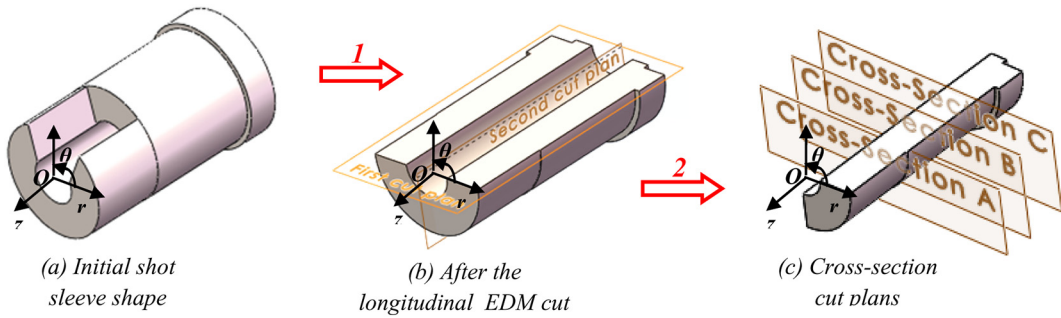
Fig. 6. CAO schema of shot-sleeve cutting planes: (a) Initial shot sleeve shape, (b) After the longitudinal EDM cut, (c) Cross-section cut plans.

The hardness profiles were measured, on a shot-sleeve longitudinal section (Fig. 6 (b)) polished until mirror state, from the entry plunger zone to the mold side and from the inner to the outer surface (Fig. 7). These profiles are performed with a Vickers hardness machine using a load of 15 kg. The measured profiles reveal that the hardness appears to be constant for all tested samples.
